# Living in a High-Performance Green Building: The Story of EPA's Region 8 Headquarters (Abridged)

U.S. General Services Administration  
Office of Federal High-Performance Green Buildings

# Living in a High-Performance Green Building: The Story of EPA’s Region 8 Headquarters (Abridged)

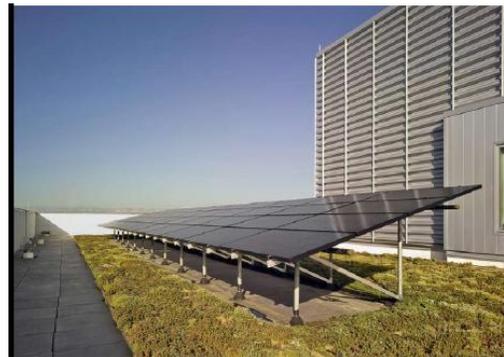
*Solar panels are on the southeast corner.*

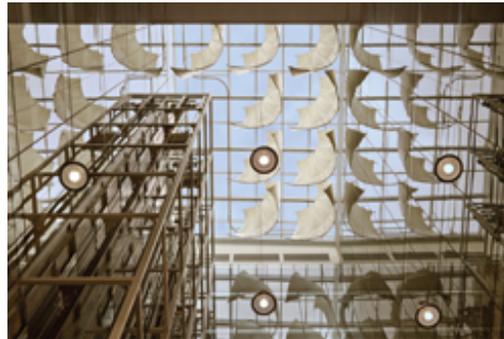
***Fabric “sails” were an innovative solution.***

The central atrium raised issues regarding how best to direct light down to the bottom of the atrium while protecting the upper levels from heat and glare. Inspired by the array of parabolic faces on the reflector grid in a light fixture, which increased its brightness and uniformity of illumination, ZGF developed a concept for a C-shaped piece of fabric, curved around

two sides of each of 15 “sails” deployed to enhance the uniformity of the light in the atrium

ZGF first went to tensile companies for fabrication, but their bids came in very high, and there were concerns that solar radiation would degrade the elastic in the fabric “sails.” ZGF then approached a Portland, OR area sailmaker about fabricating them, and a Denver-based theatrical rigging company for installation and maintenance. ZGF printed a cutting pattern from its computer model, which the chosen sailmaker used to create a scale model. The bids for fabrication and installation fell within the allowable budget, so the sails remained in the project.

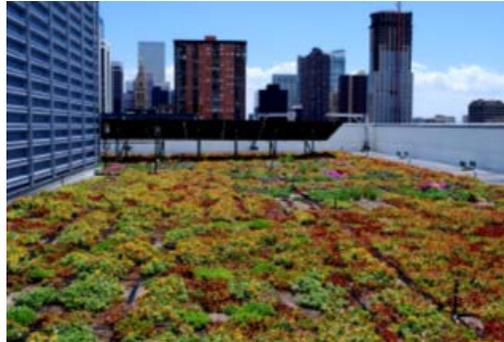
***The green roof tempered temperature swings.***

Research showed that the roof was largely successful in managing stormwater (with 75 percent of stormwater retained), mitigating heat island effect, and providing an effective irrigation system that was necessary to keep the vegetated roof healthy.

The roof is in the southern portion of the 9th floor and totals nearly 8,000 square feet (740 m<sup>2</sup>). A flat gravel ballasted roof on a renovated LEED Gold historic building

**Thermal performance.** Throughout most of the year, the vegetated roof functions as an energy sink, retaining heat in the thermal mass of the green roof growth substrate and plant materials and moderating temperature swings. A representative summer day was selected to compare thermal performance of the green roof and control roof. The temperature variation at the control roof membrane was 205 percent greater than at the green roof membrane.

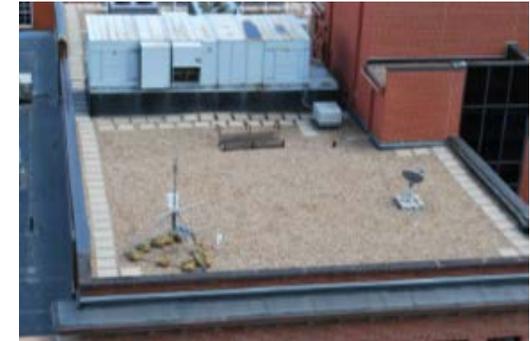
***Roof of nearby building was a study control.***

across the street served as a control roof for the study.

Temperature variation is greatest on exposed control roof surfaces, and lowest beneath the substrate surface on the green roof. This is an important observation, because such variations are the likely reason for differences in the serviceable lifespan of a vegetated roof.

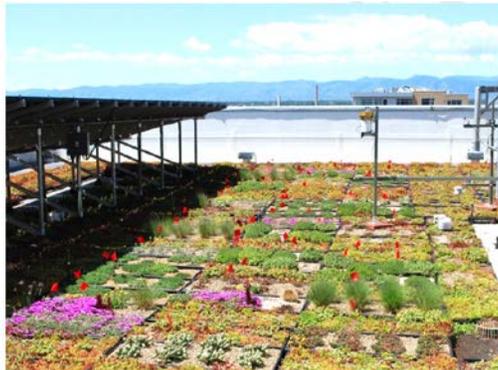
*Solar panel shade benefited the green roof.*

**Plant Protection.** A photovoltaic panel was installed on part of the vegetated roof,

causing some concern that the shade from the solar panel would harm the plants. However, research showed that the shade actually benefits the sedum plants, whereas sunlight reflected off the building glass and metal siding has caused overexposure detrimental to plantings in other areas. These two observations taken together suggest that the ambient sunlight in the region exceeds what plants require.

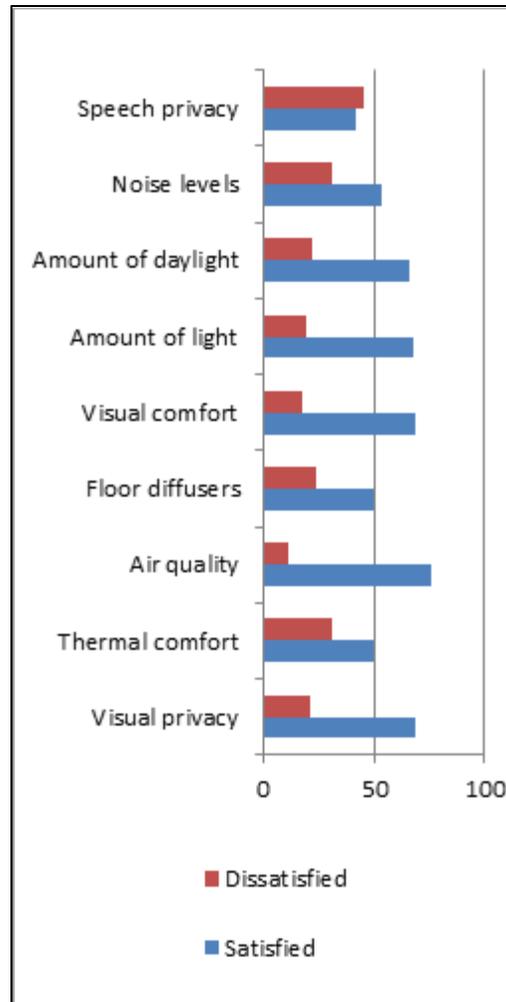
*Survey results showed occupant satisfaction.*

The vast majority of occupants are satisfied with ambient conditions and also say that the office environment helps their productivity. More than 60 percent of

respondents expressed satisfaction with the amount of daylight and electric light, visual comfort, air quality, and visual privacy. Furthermore, 62 percent said the overall quality of the environment benefited their work.

Ratings were lower for thermal comfort, speech privacy, and noise levels, a finding consistent with other workplace studies.

As the preceding graph shows, about one-third of the occupants were dissatisfied with noise levels from people talking nearby or on the phone. Even though occupants complained about such distractions, almost 60 percent of respondents said they stop and talk to people in corridors near workstations, and almost 80 percent say they learn a lot by overhearing other people's conversations. These results suggest that the acoustical environment is complex, bringing both benefits and costs for work effectiveness. Most research focuses on distractions from people talking and ignores the benefits of overhearing.

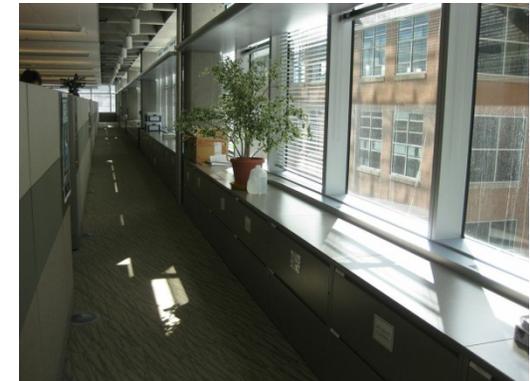
*Window shades control daylight.*

Problems with glare and sunlight are due in part to a deficiency of the design-build process. The controls and commissioning were left up to the installer, rather than having the design team document requirements and follow through during bidding, installation, and commissioning. Automated systems also require ongoing attention and maintenance to sustain their effectiveness. The problem of insufficient

daylight in some areas of the building stems from both a natural drop-off of daylight in spaces farthest from the windows and the high workstation panels that reduced daylight in the cubicles.
